**Flood Control Project Maintenance
Levee Inspections**

Maintenance Issue Types Only, Levee Inspection Report By Mile - Fall 2016

Reclamation District No. 0349 Sutter Island

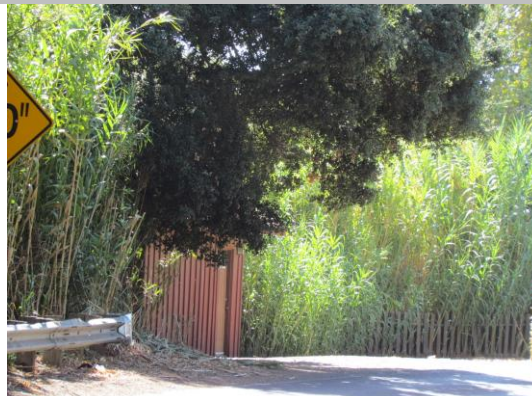
Photo 1 of 1 : FA_2016_RD0349_204_13_20161003_00026.jpg

LM Start	1.56	Rating **	U	Issue No.	13
LM End	1.58	Issue Type +	Ma	Location *	WS
Category	Earthen Levee			GPS Latitude/Longitude	
				Start	End
Item	Vegetation			38.305450 °	38.305162 °
				-121.574687 °	-121.574750 °
DWR ID	DWR_RD0349_01_f_2014_13				
Comment Code					
V2 : Remove the wild growth other than native grasses from the levee slopes.					
Inspector Comment					
This Arundo present on the waterward section is blocking the view of the levee section. Remove it from the shoulder and slope.

RD 349 Unit 1 waterside shoulder and slope.

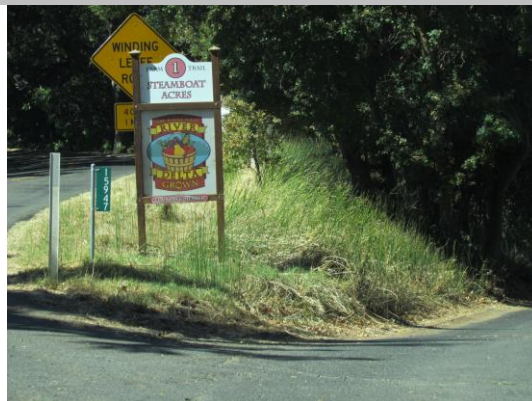
Photo 1 of 1 : FA_2016_RD0349_205_34_20161003_00077.jpg

LM Start	0.03	Rating **	U	Issue No.	34
LM End	1.31	Issue Type +	Ma	Location *	LS
Category	Earthen Levee			GPS Latitude/Longitude	
				Start	End
Item	Vegetation			38.304993 °	38.289043 °
				-121.575160 °	-121.584015 °
DWR ID	DWR_RD0349_02_f_2016_34				
Comment Code					
V1 : Control annual grass and weeds on the levee slopes and easements.					
Inspector Comment					
Control the unwanted vegetation on the landside levee slope.

RD 349 Unit 2 landside slope.

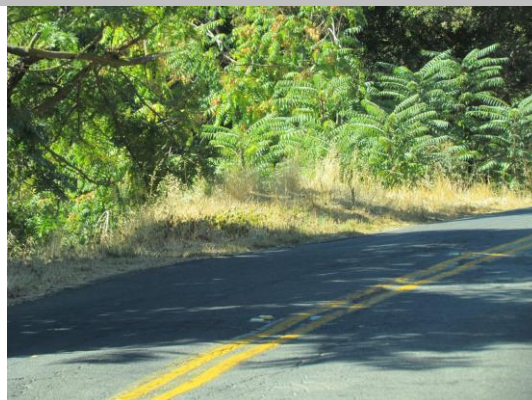
Photo 1 of 1 : FA_2016_RD0349_205_44_20161003_00078.jpg

LM Start	0.05	Rating **	U	Issue No.	44
LM End	0.57	Issue Type +	Ma	Location *	WS
Category	Earthen Levee			GPS Latitude/Longitude	
				Start	End
Item	Vegetation			38.304863 °	38.299367 °
				-121.575475 °	-121.581493 °
DWR ID	DWR_RD0349_02_s_2016_44				
Comment Code					
V2 : Remove the wild growth other than native grasses from the levee slopes.					
Inspector Comment					
Unwanted tall weeds and small trees present on the water side slope need to be removed.

RD349 Unit 2 looking downstream from the wateside shoulder and levee slope.

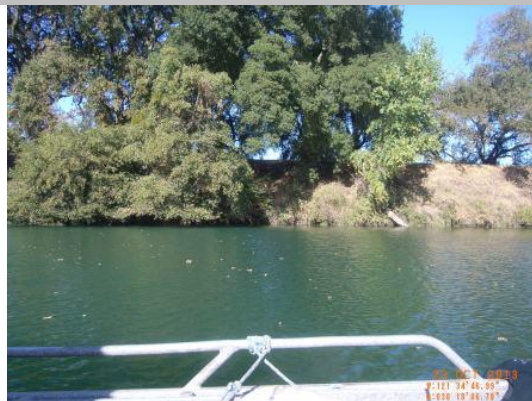
Photo 1 of 1 : FA_2016_RD0349_205_9_20160913_00007.jpg

LM Start	0.34	Rating **	M	Issue No.	9
LM End	0.39	Issue Type +	Ma	Location *	WS
Category	Supplemental			GPS Latitude/Longitude	
				Start	End
Item	2015 USACE Erosion Survey, DRAFT			38.302358 °	38.301772 °
				-121.579707 °	-121.580093 °
DWR ID	DWR_RD0349_02_s_2016_9				
Comment Code					
Inspector Comment					
2007 - Slow erosion, probably due to wave wash and fluvial erosion. Site has likely been here for awhile but was unseen due to boats parked in front. 2015: Large tree popout, scarp reaches crown of levee. [2015 Site ID: STM_25-8_R]

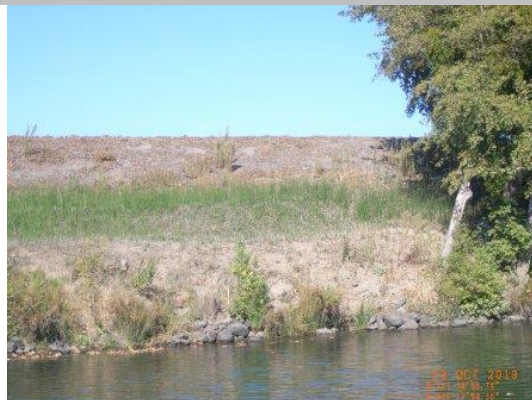
Photo 1 of 1 : FA_2016_RD0349_205_13_20160913_00010.jpg

LM Start	0.60	Rating **	M	Issue No.	13
LM End	0.72	Issue Type +	Ma	Location *	WS
Category	Supplemental			GPS Latitude/Longitude	
				Start	End
Item	2015 USACE Erosion Survey, DRAFT			38.298897 °	38.297384 °
				-121.581571 °	-121.582176 °
DWR ID	DWR_RD0349_02_s_2016_13				
Comment Code					
Inspector Comment					
2010 - Small maintenance, erosion into the toe. 2011 - Minor new erosion at toe. 2015: Minor new erosion at toe, new tree popout. [2015 Site ID: STM_25-5_R]

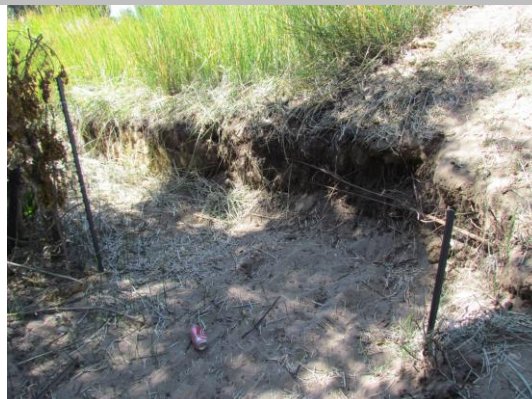
Photo 1 of 3 : FA_2016_RD0349_205_36_20161003_00079.jpg

LM Start	1.08	Rating **	U	Issue No.	36
LM End	1.08	Issue Type +	Ma	Location *	WS
Category	Earthen Levee			GPS Latitude/Longitude	
				Start	End
Item	Erosion / Bank Caving			38.292380 °	38.292282 °
				-121.583963 °	-121.583958 °
DWR ID	DWR_RD0349_02_f_2016_36				
Comment Code					
E2 : Schedule repair of erosion site prior to the next inspection.					
Inspector Comment					
Land owner damaged the slope waterside. The damage need to be repaired soon as possible.

RD 349 Unit 2 waterside slope and berm Land owner has dug a pit.

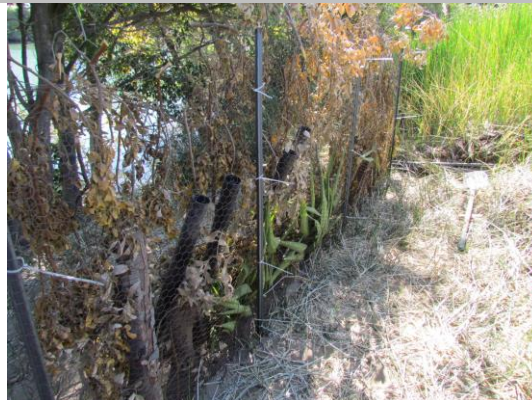
Photo 2 of 3 : FA_2016_RD0349_205_36_20161003_00084.jpg

Wind blind dug into the waterside berm lining the pit.

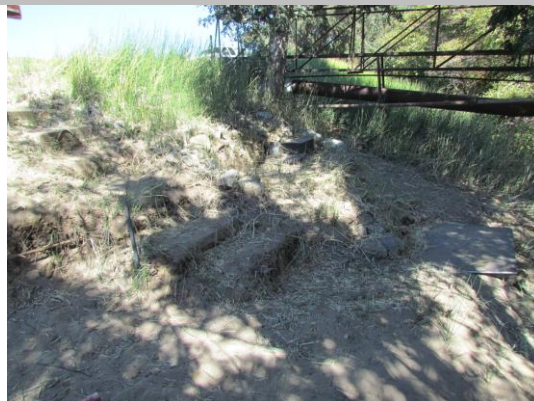
Photo 3 of 3 : FA_2016_RD0349_205_36_20161003_00088.jpg

LM Start	1.08	Rating **	U	Issue No.	36 (cont)	
LM End	1.08	Issue Type +	Ma	Location *	WS	
Category	Earthen Levee			GPS Latitude/Longitude		
				Start		End
Item	Erosion / Bank Caving			38.292380 °		38.292282 °
				-121.583963 °		-121.583958 °
DWR ID	DWR_RD0349_02_f_2016_36					
Comment Code						
E2 : Schedule repair of erosion site prior to the next inspection.						
Inspector Comment						
Land owner damaged the slope waterside. The damage need to be repaired soon as possible.

The landowner has knotted step into the waterside slope.

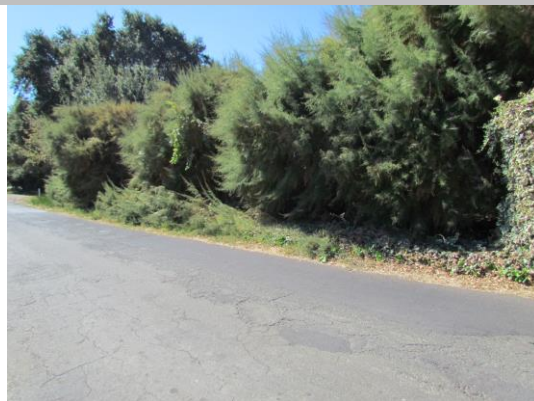
Photo 1 of 1 : FA_2016_RD0349_205_56_20161003_00089.jpg

Looking downstream from levee mile 1.33 to 2.36.

Comment Code
V7 : Trees / Woody Vegetation
Inspector Comment
Remove this unwanted woody tree growth and wild vegetation from the levee slope landward.

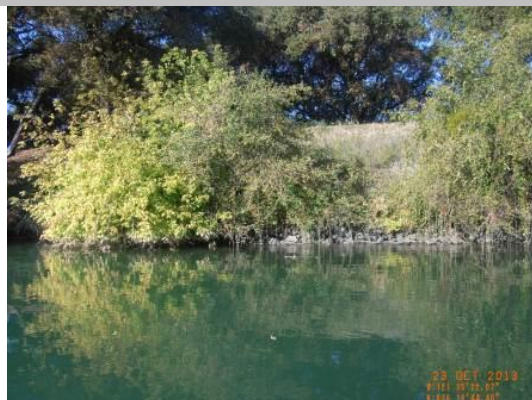
Photo 1 of 1 : FA_2016_RD0349_205_16_20160913_00011.jpg

LM Start	2.11	Rating **	M	Issue No.	16
LM End	2.14	Issue Type +	Ma	Location *	WS
Category	Supplemental			GPS Latitude/Longitude	
				Start	End
Item	2015 USACE Erosion Survey, DRAFT			38.279017 °	38.278597 °
				-121.589615 °	-121.589854 °
DWR ID	DWR_RD0349_02_s_2016_16				
Comment Code					
Inspector Comment					
1997 - Top right bank has retreated into the levee. Site is between two rock sites. 1999 - Downstream half of the reach repaired with rock. 2000 - Trees leaning into the water. 2010 - Site appears worse. 2011 - New erosion at the toe. 2013 - Short vertical sections observed at upstream end. 2015: Minor new erosion. [2015 Site ID: STM_23-9_R]

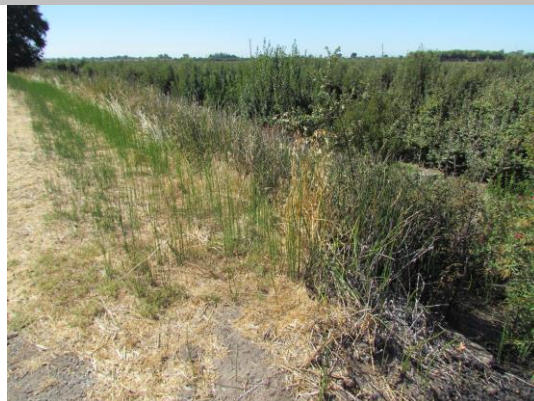
Photo 1 of 1 : FA_2016_RD0349_205_64_20161017_00091.jpg

LM Start	2.36	Rating **	U	Issue No.	64
LM End	4.30	Issue Type +	Ma	Location *	LS
Category	Earthen Levee			GPS Latitude/Longitude	
				Start	End
Item	Vegetation			38.275795 °	38.254703 °
				-121.591428 °	-121.599703 °
DWR ID	DWR_RD0349_02_s_2016_64				
Comment Code					
V2 : Remove the wild growth other than native grasses from the levee slopes.					
Inspector Comment					
The wild weeds on the landside slope and toe needs to be removed.

RD 349 Unit 2 looking downstream from levee mile 2.36 landside slope and toe.

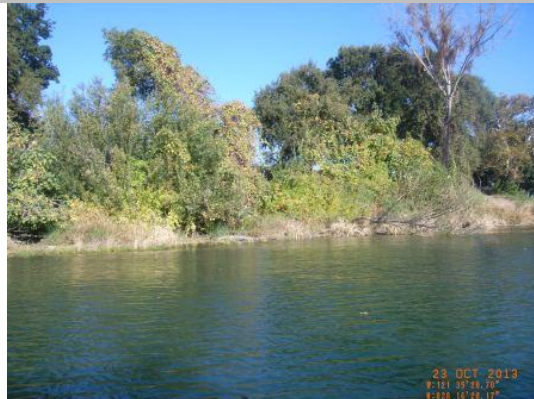
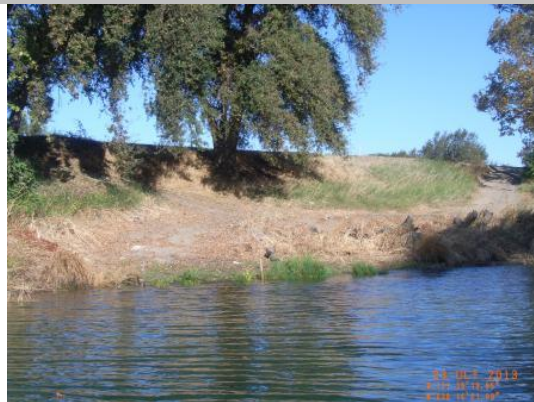
LM Start	2.56	Rating **	M	Issue No.	3
LM End	2.69	Issue Type +	Ma	Location *	WS
Category	Supplemental			GPS Latitude/Longitude	
				Start	End
Item	2015 USACE Erosion Survey, DRAFT			38.273854 °	38.271998 °
				-121.588745 °	-121.589424 °
DWR ID	DWR_RD0349_02_s_2016_3				
Comment Code					
Inspector Comment					
2011 - Toe scour at the tidal zone. 2015: New tree popout and minor new erosion. [2015 Site ID: STM_23-6_R]

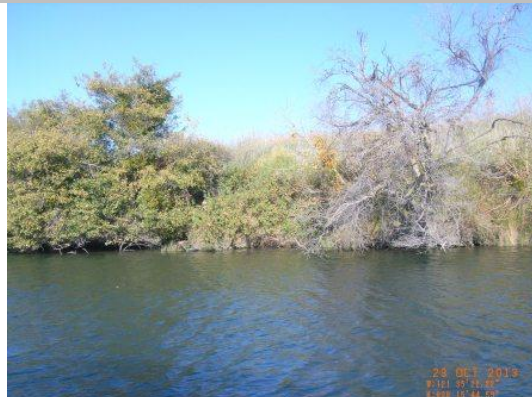
Photo 1 of 1 : FA_2016_RD0349_205_11_20160913_00009.jpg

LM Start	3.38	Rating **	M	Issue No.	11
LM End	3.49	Issue Type +	Ma	Location *	WS
Category	Supplemental			GPS Latitude/Longitude	
				Start	End
Item	2015 USACE Erosion Survey, DRAFT			38.262510 °	38.262533 °
				-121.589481 °	-121.591690 °
DWR ID	DWR_RD0349_02_s_2016_11				
Comment Code					
Inspector Comment					
2010 - Slumping sections on the lower bank, appears to be scouring around the trees. 2011 - Soil beach at toe. 2015: No observed changes. [2015 Site ID: STM_22-8_R]

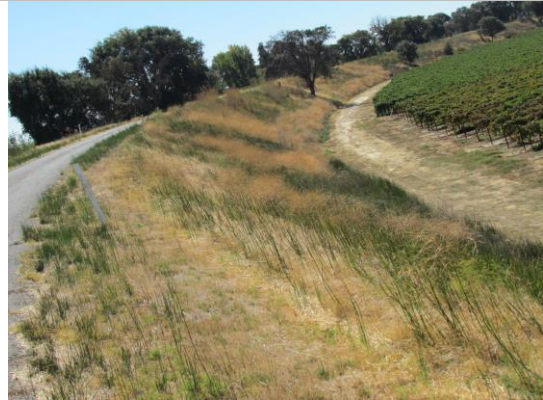
Photo 1 of 1 : FA_2016_RD0349_205_40_20161017_00094.jpg

LM Start	3.94	Rating **	U	Issue No.	40
LM End	4.31	Issue Type +	Ma	Location *	LS
Category	Earthen Levee			GPS Latitude/Longitude	
				Start	End
Item	Vegetation			38.258062 °	38.254715 °
				-121.595153 °	-121.599900 °
DWR ID	DWR_RD0349_02_f _ 2016_40				
Comment Code					
V1 : Control annual grass and weeds on the levee slopes and easements.					
Inspector Comment					
Control the wild vegetation growth on the landside levee slope.

RD 349 Unnit 2 levee mile 3.94-4.31 looking downstream.

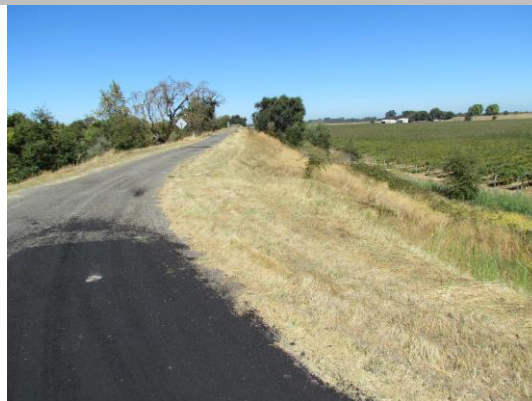
Photo 1 of 1 : FA_2016_RD0349_206_34_20161017_00070.jpg

LM Start	0.00	Rating **	U	Issue No.	34
LM End	1.52	Issue Type +	Ma	Location *	LS
Category	Earthen Levee			GPS Latitude/Longitude	
				Start	End
Item	Vegetation			38.254752 °	38.275993 °
				-121.600067 °	-121.601013 °
DWR ID	DWR_RD0349_03_f_2016_34				
Comment Code					
V2 : Remove the wild growth other than native grasses from the levee slopes.					
Inspector Comment					
Tall weeds on the landside levee slope need to be removed from the levee section.

RD 349 Unit 3 landside levee slope landside.

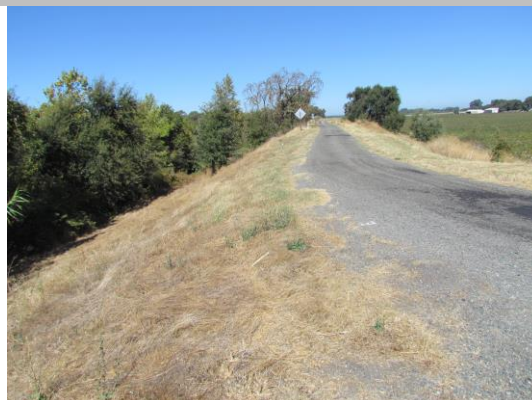
Photo 1 of 1 : FA_2016_RD0349_206_35_20161017_00071.jpg

LM Start	0.00	Rating **	U	Issue No.	35
LM End	2.74	Issue Type +	Ma	Location *	WS
Category	Earthen Levee			GPS Latitude/Longitude	
				Start	End
Item	Vegetation			38.254752 °	38.292205 °
				-121.600067 °	-121.603727 °
DWR ID	DWR_RD0349_03_f_2016_35				
Comment Code					
V2 : Remove the wild growth other than native grasses from the levee slopes.					
Inspector Comment					
Tall weeds on the waterside levee slope need to be removed.

RD 349 Unit 3 levee mile 0.00 waterside slope.

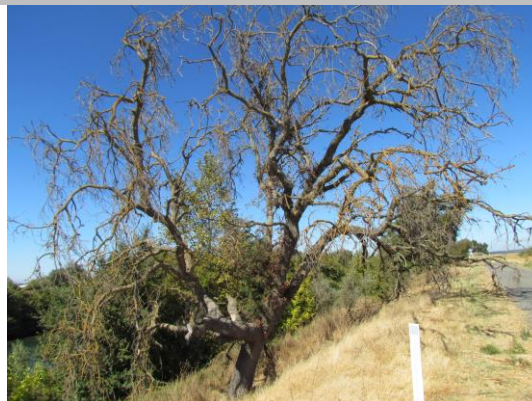
Photo 1 of 1 : FA_2016_RD0349_206_37_20161017_00072.jpg

LM Start	0.04	Rating **	U	Issue No.	37
LM End	0.04	Issue Type +	Ma	Location *	WS
Category	Earthen Levee			GPS Latitude/Longitude	
				Start	End
Item	Encroachments			38.255327°	38.255327°
				-121.600033°	-121.600033°
DWR ID	DWR_RD0349_03_f_2016_37				
Comment Code					
TR : Tree or limb					
Inspector Comment					
Dead tree on the waterside slope (large). This tree will fall and block access to the levee crown roadway.

RD 349 Unit 3 levee mile 0.04 waterside slope.

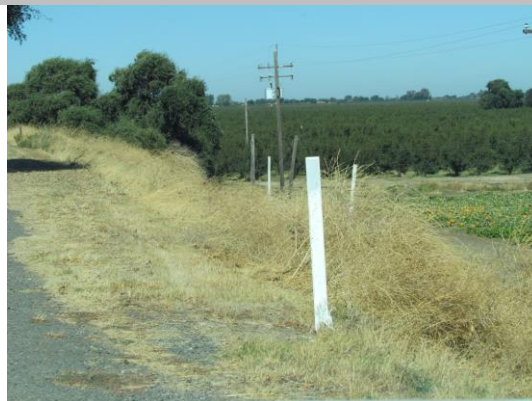
Photo 1 of 1 : FA_2016_RD0349_206_39_20161017_00073.jpg

LM Start	1.77	Rating **	U	Issue No.	39
LM End	6.31	Issue Type +	Ma	Location *	LS
Category	Earthen Levee			GPS Latitude/Longitude	
				Start	End
Item	Vegetation			38.279535 °	38.329043 °
				-121.600312 °	-121.579382 °
DWR ID	DWR_RD0349_03_f_2016_39				
Comment Code					
V1 : Control annual grass and weeds on the levee slopes and easements.					
Inspector Comment					
There hasn't been any maintenance done to the levee slope landside and the waterside from here to the end levee mile 6.31.

RD 349 Unit 3 levee mile 1.77 through to levee mile 6.31.

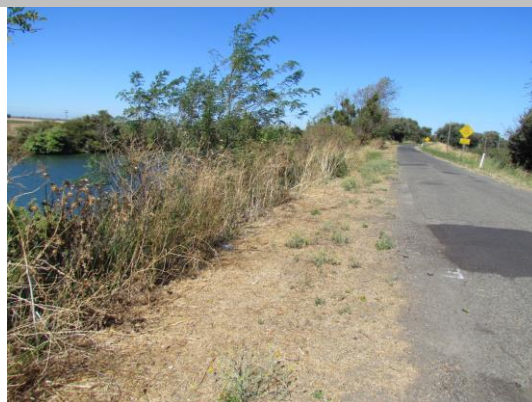
Photo 1 of 1 : FA_2016_RD0349_206_41_20161017_00074.jpg

LM Start	3.02	Rating **	U	Issue No.	41
LM End	6.31	Issue Type +	Ma	Location *	WS
Category	Earthen Levee			GPS Latitude/Longitude	
				Start	End
Item	Vegetation			38.296065 °	38.329043 °
				-121.604718 °	-121.579382 °
DWR ID	DWR_RD0349_03_f_2016_41				
Comment Code					
V1 : Control annual grass and weeds on the levee slopes and easements.					
Inspector Comment					
From levee mile 3.02 to levee mile 6.31 water side slope is overgrown with tall weeds and other wild vegetation.

RD 349 Unit 3 levee mile 3.02 looking downstream waterside.

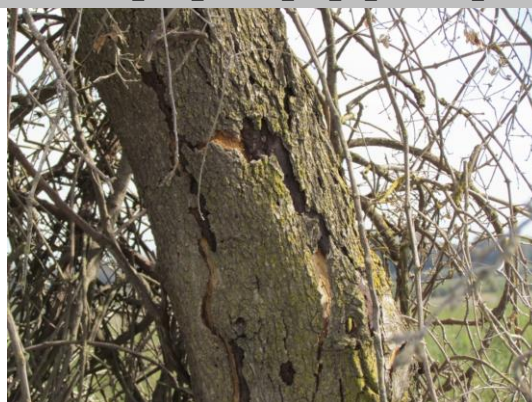
Photo 1 of 2 : FA_2016_RD0349_206_73_20160913_00004.jpg

LM Start	3.19	Rating **	U	Issue No.	73
LM End	3.19	Issue Type +	Ma	Location *	LS
Category	Earthen Levee			GPS Latitude/Longitude	
				Start	End
Item	Trim / Thin Trees			38.298223 °	38.298223 °
				-121.603240 °	-121.603240 °
DWR ID	DWR_RD0349_03_f_2014_73				
Comment Code					
T4 : Trim trees over roadway to at least 12 feet above ground level.					
Inspector Comment					
This tree on the landside slope is rotten and could possibly fall across levee section.

Close up view of dead tree standing above crown roadway.

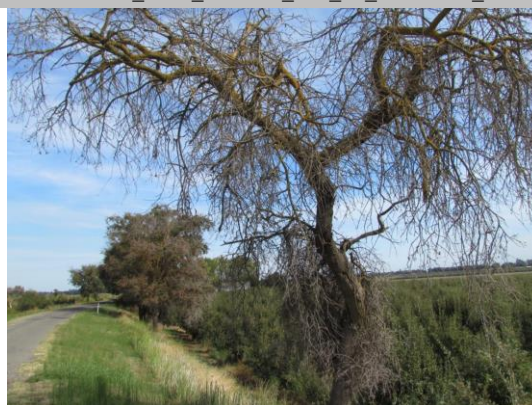
Photo 2 of 2 : FA_2016_RD0349_206_73_20160913_00005.jpg

Dead tree above crown roadway landward.

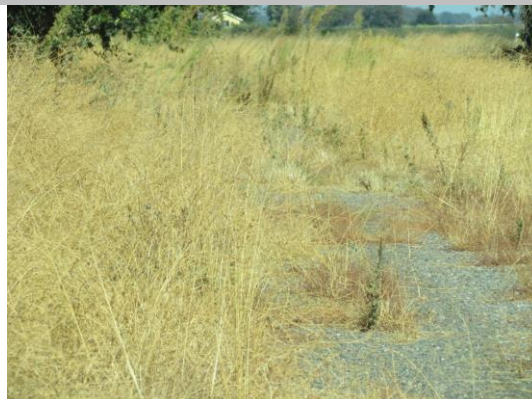
Photo 1 of 1 : FA_2016_RD0349_206_80_20160913_00006.jpg

LM Start	4.74	Rating **	U	Issue No.	80
LM End	6.30	Issue Type +	Ma	Location *	CR
Category	Earthen Levee			GPS Latitude/Longitude	
				Start	End
Item	Vegetation			38.316183 °	38.329088 °
				-121.590735 °	-121.579400 °
DWR ID	DWR_RD0349_03_f_2015_80				
Comment Code					
V9 : Keep the crown roadway free of vegetation.					
Inspector Comment					
The crown roadway should be keep free of vegetation. No new picture, the conditions has not changed since last inspection.

RD 349 Levee mile 4.74 looking at overgrown crown roadway. Weeds are taller than four feet. Extreme fire hazard.
